## **Canopy Arm Quality Issues Investigation Status** June 6, 2019

## **Canopy Quality Issues**

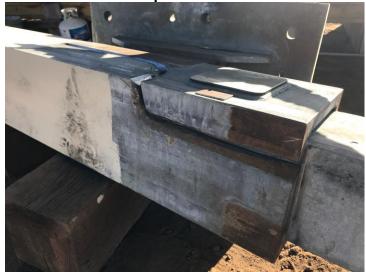
West Oahu Station Group – Ho'opili Station

Lower frame segment crack – 1 Frame Nan, Inc. & TMP (fabricator)

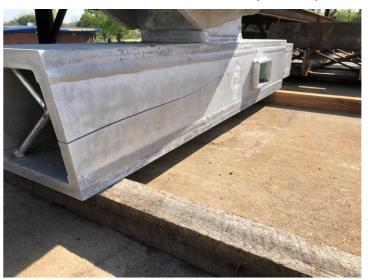
– West Loch Station (WLO)

Lower frame segment cracks – 4 Frames HDCC, Inc. & SSW (fabricator)

- WOSG collecting documentation; field weld repair was unacceptable
- FHSG canopy frame lower segment analysis begun 80%-90% of crack filled with zinc (galvanizing material)
- Preliminary hypothesis based upon Wiss, Janney, Elstner (WJE) assessment: Cracks are result of either liquid metal embrittlement (LME), hydrogen embrittlement (HE) or strain age embrittlement
- High residual stresses due to fabrication methods (e.g. welding and plasma cutting) and thermal shock due to hot dip galvanization (HDG) Lower segment is Grade 100 steel
- KHSG Gr 100 fabrication on hold
